SAN DIEGO FLEET MOORINGS INSPECTION REPORT

30 NOVEMBER

OCEAN ENGINEERING AND CONSTRUCTION PROJECT OFFICE
CHESAPEAKE DIVISION
NAVAL FACILITIES ENGINEERING COMMAND
WASHINGTON, DC 20374

FPO-1-82 (29)

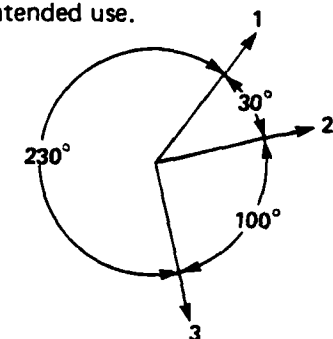
MOORING NO.: DM-3 CLASS: D LOCATION: DETERMINING PIER LAT: _____ LONG: _____

The riser was found to consist of 2 1/2 inch chain which is larger than the 2 inch chain specified for a class D mooring in DM-26. Double link measurements along the riser chain indicated >80% of the original wire diameter was remaining. Divers reported 5 to 6 inch thick marine growth on the buoy bottom and riser chain. Significant amounts of corrosion were observed on the chain by divers. The ground ring was located at a water depth of 32 feet.

COMPONENTS	BRNG	CONDITION							U/W VOLT READING	COMMENT	
		NEW FROM PARTS LIST	SINGLE LINK %			DOUBLE LINK %					
			90+	80+	80-	90+	80+	80-			D
BUOY-TOP HARDWARE											
RISER	NEAR BUOY	2 1/2	2 1/2								Painted, wooden tenders
	MIDDLE	2 1/2	2 1/2					✓			Good Condition Divers reported
	NEAR GRD RG	2 1/2	2 1/2								"LOTS OF OXIDATION" on chain
GROUND RING											
GROUND LEG NO. <u>1</u>	UPPER END	2"	2 1/2					✓			10' from Ground Ring chain buried in mud
	WEARPOINT										approx. 31 feet from Ground Ring
GROUND LEG NO. <u>2</u>	UPPER END		2 1/2					✓			10' from Ground Ring chain buried in mud
	WEARPOINT										approx. 25 feet from Ground Ring
GROUND LEG NO. <u>3</u>	UPPER END		2 1/2					✓			10' from Ground Ring chain buried in mud
	WEARPOINT	↓									approx. 22 feet from Ground Ring

Divers measured 2 1/2 inch mooring chain, which indicates a Class B mooring, according to DM-26. Records indicate San Diego uses this mooring as a Class D fleet mooring.

The chain on this mooring was found to have >80% of its original wire diameter remaining, which normally indicates a need to downgrade the mooring by one class. The resulting Class C is still higher than the Class D required so this mooring should be adequate for its intended use.

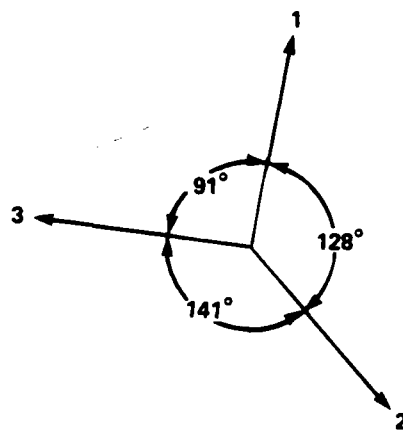
Ground legs 1 and 2, (2 inch wire diameter), were measured and reported to be in good condition. Ground leg 3 (2 1/4 inch chain) was reported to have severe wear and was badly pitted (>75%). The variation in double and single link measurements indicates that ground leg 3 may consist of segments of different sized chain.

COMPONENTS		BRNG	CONDITION						UW VOLT READING	COMMENT
			NEW PARTS LIST	SINGLE LINK %			DOUBLE LINK %			
BUOY-TOP HARDWARE										
RISER	NEAR BUOY		2 1/2"					4 3/4"		PAINTED; TOP FENDERS - No Robbing
	MIDDLE		↓					4 7/8"		
	NEAR GRD RG		↓					5"		
GROUND RING										
GROUND LEG NO. 1	UPPER END	009°	2"	2"				4"		
	WEARPOINT		↓							
GROUND LEG NO. 2	UPPER END	132°	↓	2"				4 1/4"		
	WEARPOINT		↓							
GROUND LEG NO. 3	UPPER END	273°	↓	2 1/4"						+75% BADLY PITTED CHAIN CHAIN MEASURED 15' from Ground Ring
	WEARPOINT		↓

- DM-4: Ground leg 3 which measured <80% of original wire diameter must be replaced as soon as possible. Use of this mooring should be discontinued until an overhaul is completed.

It is recommended that this mooring be discontinued for fleet use, until it has been overhauled. The basis for this recommendation is the double link measurement found on ground leg 3 which indicated original wire diameter remaining to be <80%.

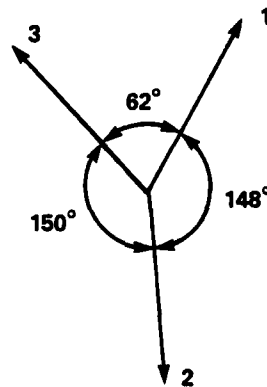
MOORING NO.: DM-11 CLASS: D LOCATION: DETERMINS LAT: LONG:
 WATER DEPTH: 35' / 34' TYPE MOORING: ☒ RISER ☐ TELEPHONE ANCHOR SIZE/TYPE: A3 BUOY TYPE: 206-707-12' 9" 44' 12'

The painted peg-top buoy with a 12 foot diameter and 3 1/2 foot freeboard was reported to be without a chafing rail and was observed to have only one fender. Four to five inches of marine growth was reported. The general condition of the buoy was satisfactory.

The 2 3/4 inch riser chain was reported to be in good condition. Rings of 4 1/2 inch wire diameter are used to attach the riser chain and all three of the ground legs to the ground ring. The ground ring was located at a water depth of 29 feet.

COMPONENTS		BRNG	CONDITION							U/W VOLT READING	COMMENT
			NEW ASSEMBLY	SINGLE LINK %		DOUBLE LINK %			D		
				80+	80-	80+	80-	80+			
BUOY-TOP HARDWARE	NEAR BUOY										No robbing rail, wooden fence 4-5 inches of marine growth
	MIDDLE										
	NEAR GRD RG										
GROUND RING										29'	
GROUND LEG NO. <u>1</u>	UPPER END		2 1/4"							4 3/8	
	WEARPOINT	027°									
GROUND LEG NO. <u>2</u>	UPPER END									4 1/8	
	WEARPOINT	175°									
GROUND LEG NO. <u>3</u>	UPPER END									4 1/8	
	WEARPOINT	325°

This mooring has been inspected and reported as satisfactory. The present status of this mooring is Class B by DM-26 specifications. PWC San Diego has been reporting it as a Class D fleet mooring.

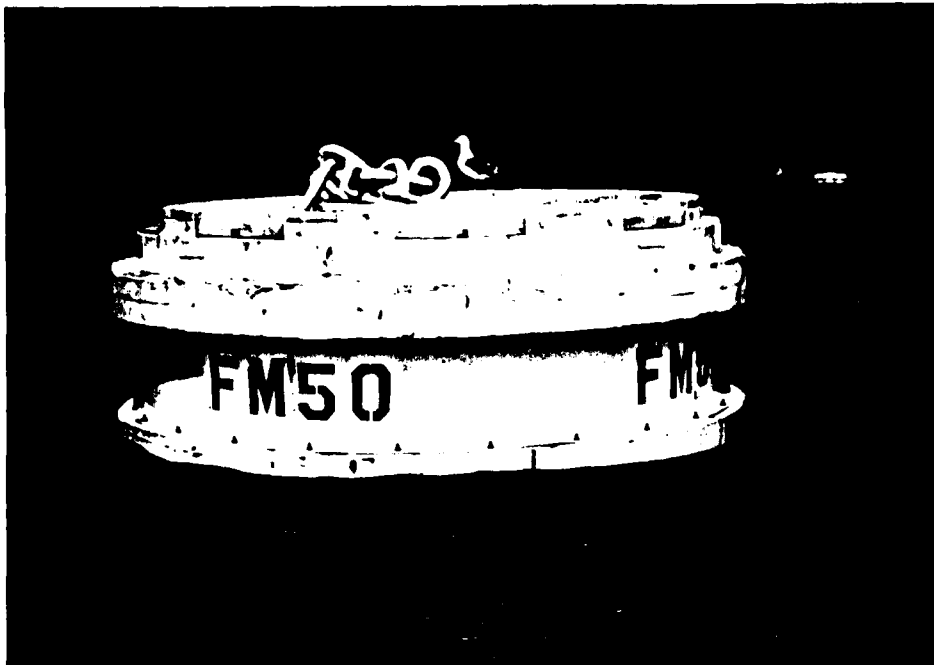
Painted metal peg-top buoy with a double wooden fender at the top and a single fender at the waterline. An example of a buoy in excellent condition.
